RANGE HOODS / BUILT-IN

ELITE-PRO

24036-S • (36"-860 CFM - Stainless steel)

SPÉCIFICATIONS TECHNIQUES

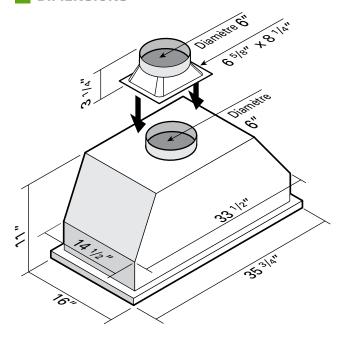
DIMENSIONS

- · Stainless steel finish
- 860 CFM
- Noise level: low speed 0.7 to hi 9.0 sones (high speed)
- 3 speed with time delay
- 2 LED bulbs. 5W (incl.)
- Stainless steel baffle filters (incl.)
- 6" round vertical vent exhaust
- Weight: 37 lbs
- Opening required: 14 5/8" x 33 5/8"
