RANGE HOODS / WALL-MOUNT

SLIM

24900-390-BK • (30" - 390 CFM)

24900-480-BK • (30" - 480 CFM)

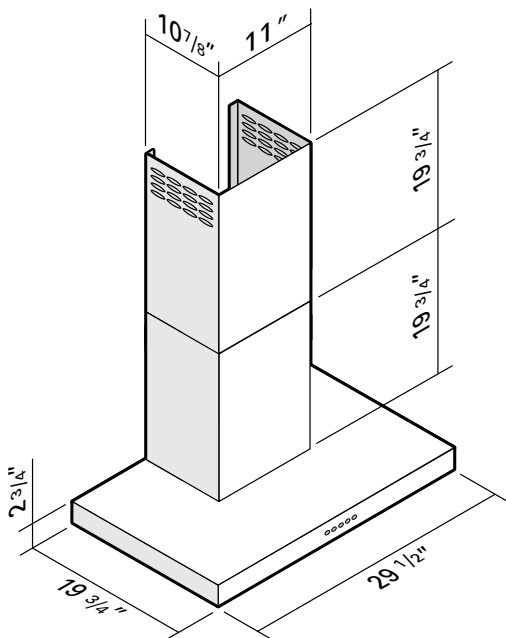
DIMENSIONS

- Black finish
- 390 and 480 CFM
- Noise level: low speed 0.6 to hi 8.0 sones (high speed)
- 3-speed control
- 2 LED bulbs, 5W (incl.)
- 5-layer aluminum filters (incl.)
- 6" round vertical vent exhaust
- Telescopic chimney
19 3/4" (bottom section) -
19 3/4" (top section)
- Optional 30" chimney for ceilings up to 10 feet
- Good for ceilings up to 8 ft 6 in. (For 9' (108") ceilings, the hood can be installed using the sections of chimney provided, as long as it is installed at a distance of at least 31" from the counter.)
