# PROFESSIONAL RANGE HOODS / UNDER-CABINET

## PRO DESIGNER

**24836-S • (36"- 1000 CFM - Stainless steel)**

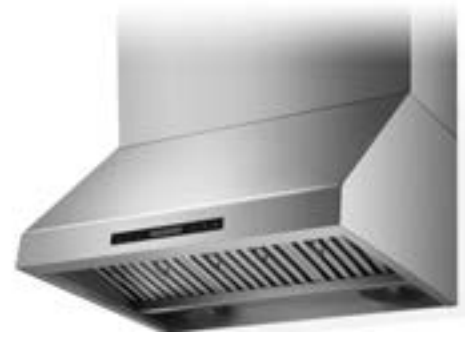
### DIMENSIONS

- 1000 CFM
- Noise level: low speed 0.9 to hi 11.0 sones (high speed)
- 4-speed electronic control panel, LCD - Clock
- 2 LED bulbs, 2W, with 2 light levels (incl.)
- Stainless steel baffle filters (incl.)
- 8" vent exhaust
- Chimney extension available. 12"x 12"x 36" (#C24836 Optional)
