RANGE HOODS / BUILT-IN

ELITE-PRO

24030-S • (30"- 600 CFM - Stainless steel)

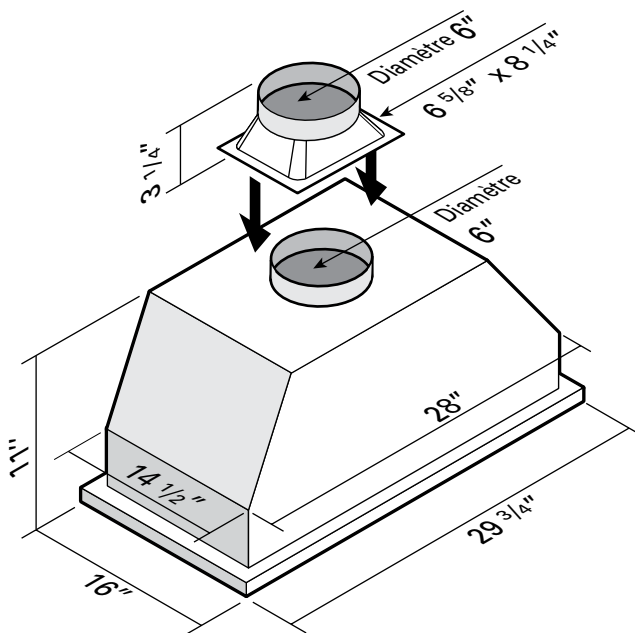
DIMENSIONS

- Stainless steel finish
- 600 CFM
- Noise level: low speed 0.7 to hi 9.0 sones (high speed)
- 3 speed with time delay
- 2 LED bulbs, 5W (incl.)
- Stainless steel baffle filters (incl.)
- 6" round vertical vent exhaust
- Weight: 32 lbs
- Opening required: 14 5/8" x 28 1/8"
