RANGE HOODS / BUILT-IN

ELITE

24122-S • (22"- 490 CFM - Stainless steel)

TECHNICAL SPECIFICATIONS

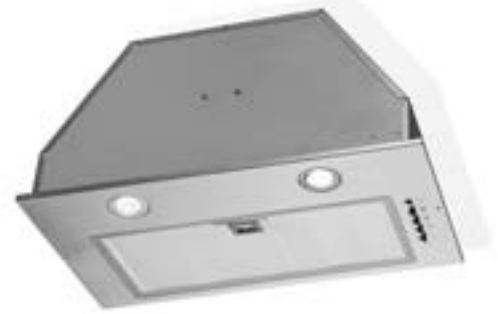
DIMENSIONS

- Stainless steel finish
- 490 CFM
- Noise level: low speed 0.6 to hi 8.0 sones (high speed)
- 3-speed soft-touch controls
- 2 LED bulbs, 5W (incl.)
- 5-layer aluminum filters (incl.)
- Charcoal filter available (#CF24000 Optional)
- 6" round vertical vent exhaust
- Weight: 28,5 lbs
- Opening required: 10 1/4" x 19 1/2"
