# RANGE HOODS / BUILT-IN

# **ELITE**

**24128-S** • (28"- 490 CFM - Stainless steel)

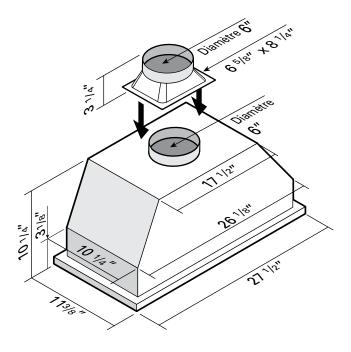
# **DIMENSIONS**

- · Stainless steel finish
- 490 CFM
- Noise level: low speed 0.6 to hi 8.0 sones (high speed)
- 3-speed soft-touch controls
- 2 LED bulbs. 5W (incl.)
- 5-layer aluminum filters (incl.)
- 6" round vertical vent exhaust
- Opening required: 10 1/4" x 26 1/2"
