RANGE HOODS / BUILT-IN

ELITE-PRO

24036-S • (36"- 860 CFM - Stainless steel)

SPÉCIFICATIONS TECHNIQUES

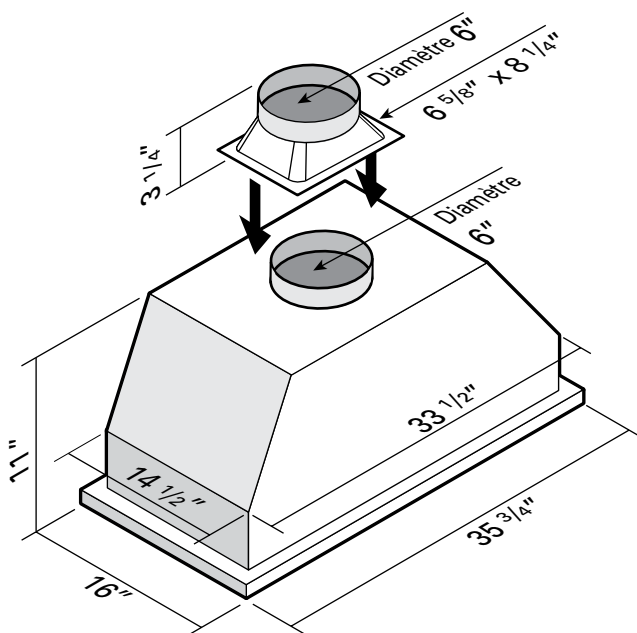
DIMENSIONS

- Stainless steel finish
- 860 CFM
- Noise level: low speed 0.7 to hi 9.0 sones (high speed)
- 3-speed push button
- 2 LED bulbs, 5W (incl.)
- Stainless steel baffle filters (incl.)
- 6" round vertical vent exhaust
- Weight: 37 lbs
- Opening required: 14 5/8" x 33 5/8"
