RANGE HOODS / ISLANDS

SLIM - ISLAND

24936-860-S • (36" - 860 CFM)

TECHNICAL SPECIFICATIONS

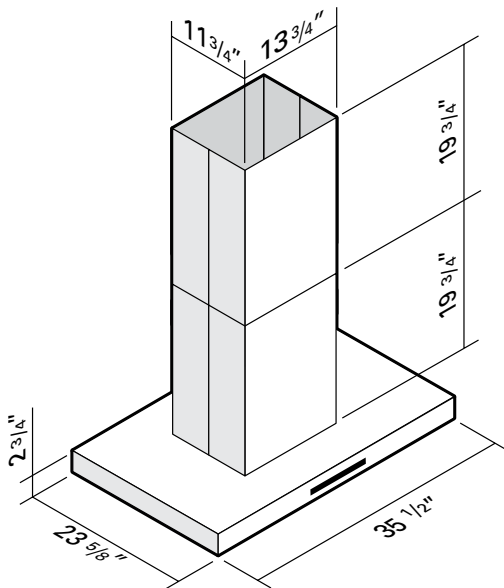
DIMENSIONS

- Stainless steel finish
- 860 CFM
- Noise level: low speed 0.7 to hi 9.0 sones (high speed)
- 3-speed electronic control panel, LCD with clock
- Remote control
- 4 LED bulbs, 5W (incl.)
- Stainless steel baffle filters (incl.)
- 6" round vertical vent exhaust
- Telescopic chimney 19 3/4" (bottom section) - 19 3/4" (top section)
- 35" chimney in option
- Good for ceilings up to 8 ft 6 in. (For 9' (108") ceilings, the hood can be installed using the sections of chimney provided, as long as it is installed at a distance of at least 31" from the counter.)
